# **Lower Chicopee River Watershed Stormwater Assessment Project**

**Final Report  
2014-02/604**

**June 30, 2017**

**Prepared By Pioneer Valley Planning Commission  
Chicopee 4Rivers Watershed Council**

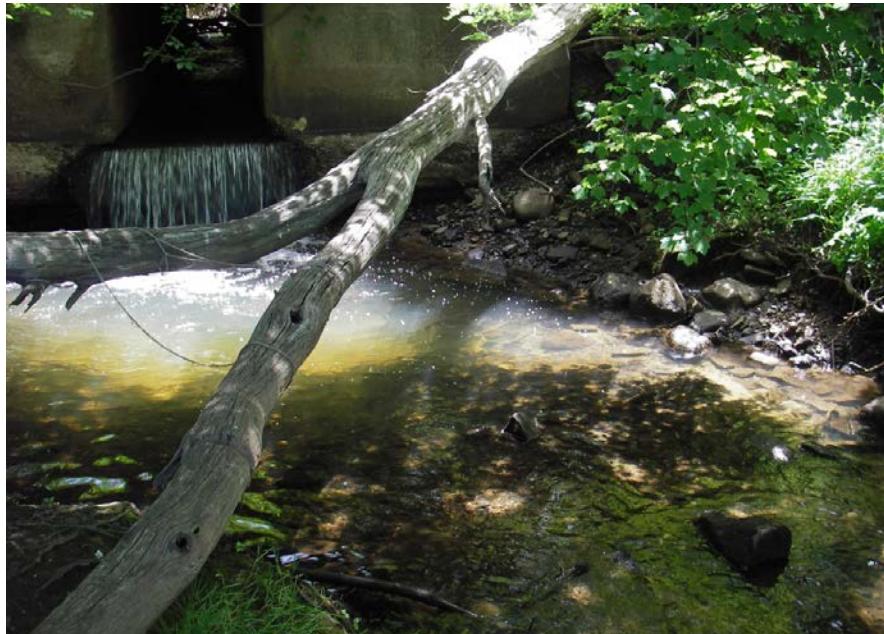
*Outfall at Grochmal Avenue that delivers flow to the Chicopee River.*

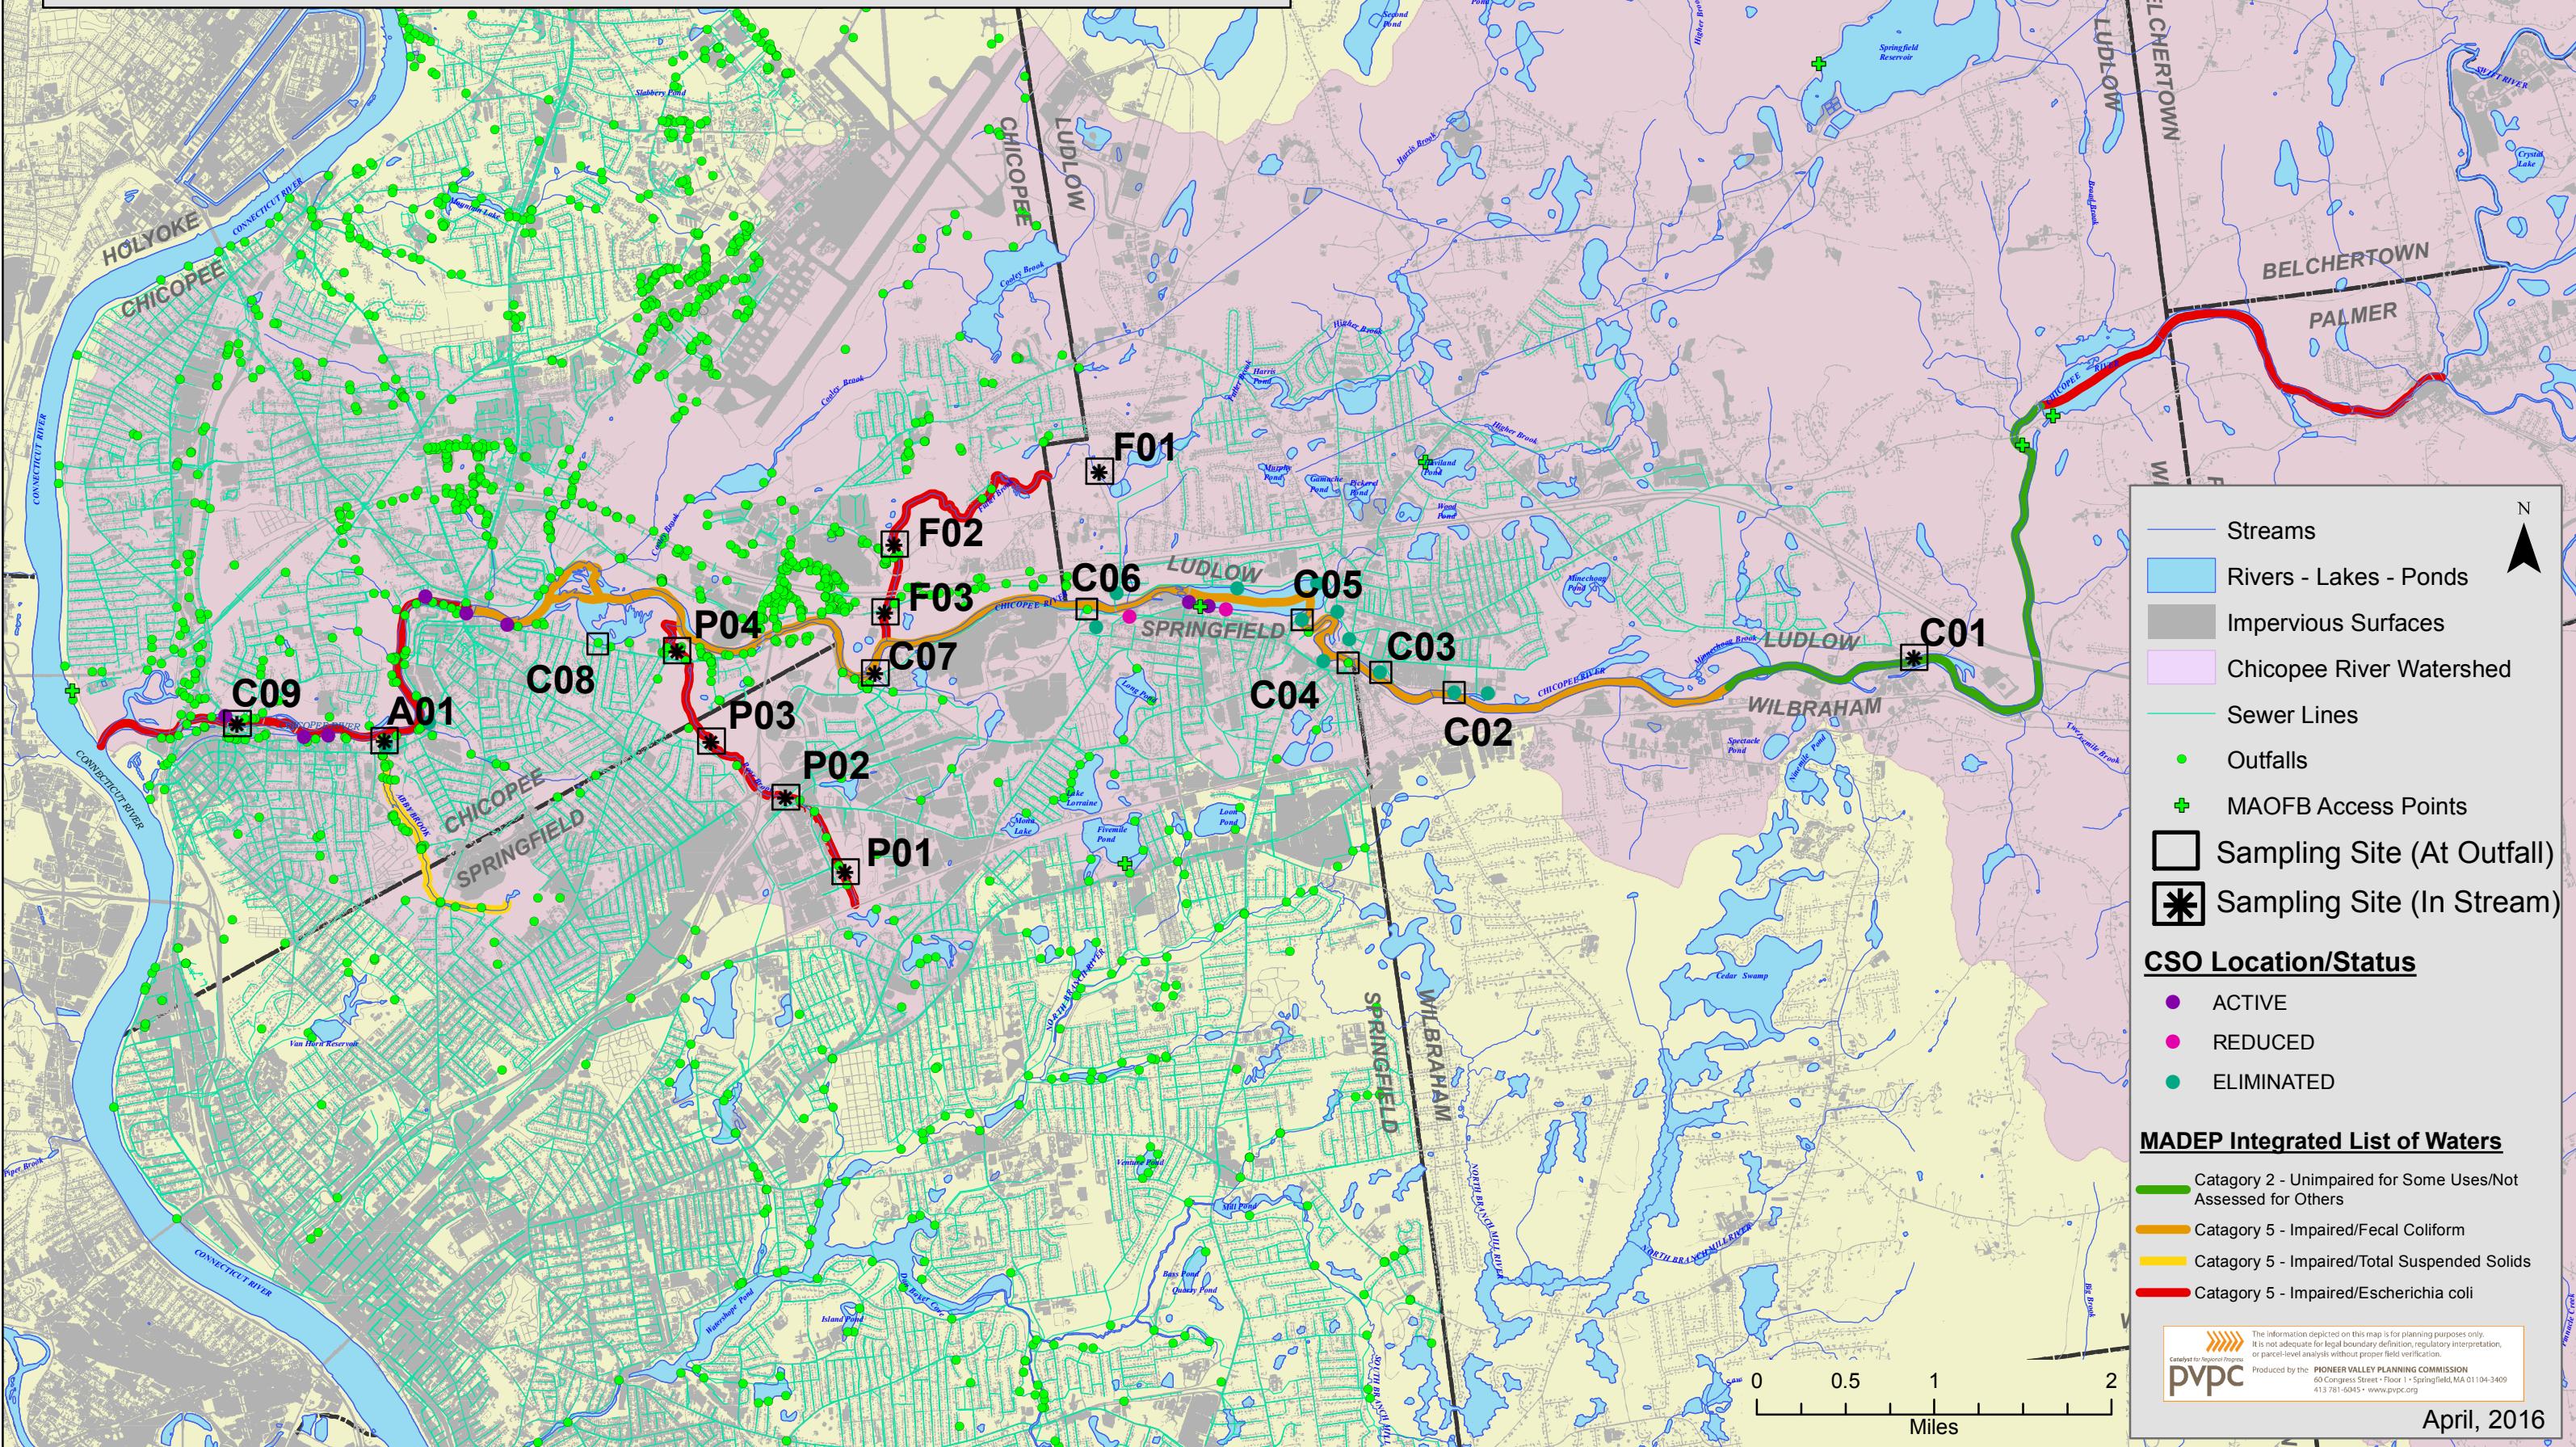
# Chicopee River Water Quality Sampling Locations

## Chicopee - Ludlow - Springfield

Table 1 below identifies each site, the rationale for site selection, and previous data available associated with the location if available. Map 1 below shows the sampling locations.

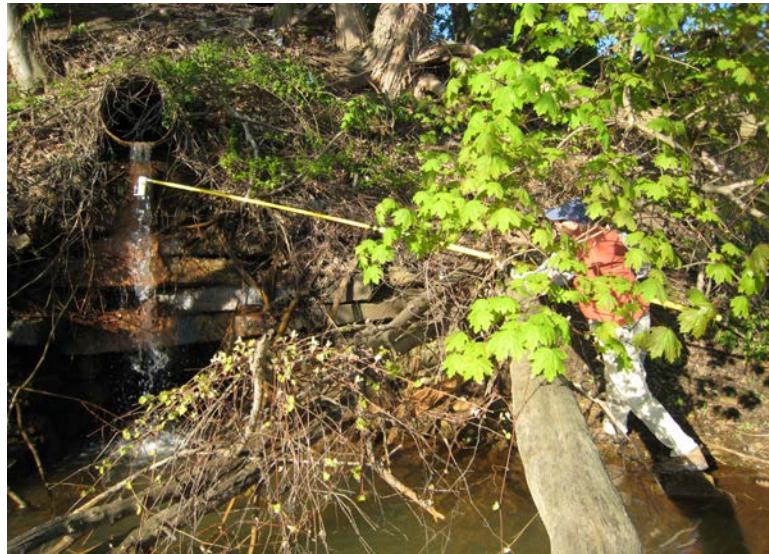
*Volunteer Alan Menard reaches to collect a sample at an outfall to the Chicopee River (C08). Getting to this site required permission to walk through the back yard of private property owner at 525 Main Street, Chicopee, and then steep climb down to River's edge.*

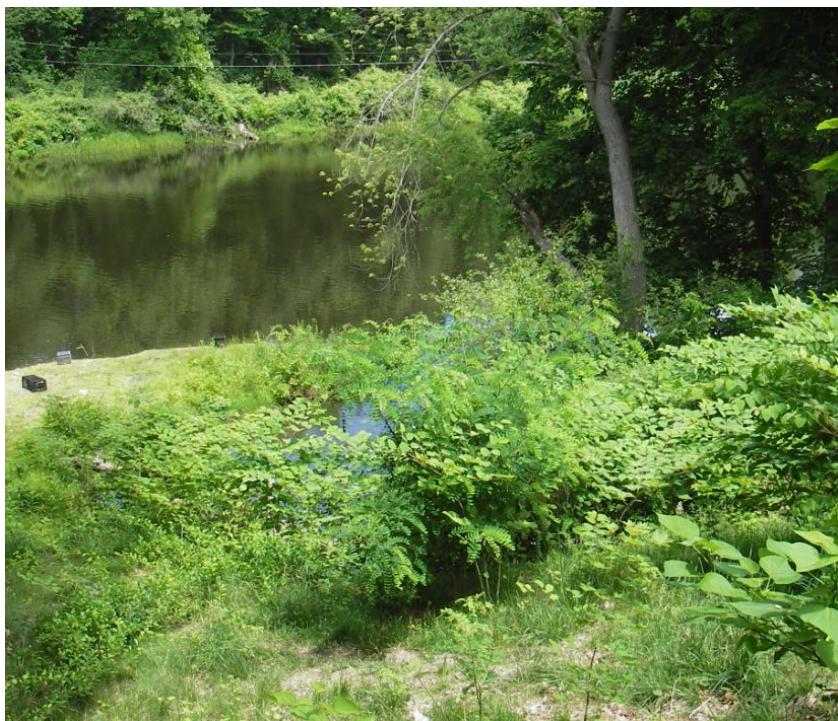
*Abbey Brook confluence with the Chicopee River. Just before it reaches this location, Abbey Brook spills out of a highly perched culvert.*

- The outfall of Abbey Brook at the Chicopee River (A01) showed elevated levels of *E. coli* bacteria during all four sampling events.
- In stream locations on Fuller Brook showed repeated problems with elevated *E. coli* during the wet sampling events, with the middle of the system site (F02) showing high hits during three sampling events and the upper (F01) and lower (F03) sites on the system showing high hits during two sampling events.
- The outfall at Grochmal Street (CO7) showed elevated bacteria on two occasions.
- The two instream sampling locations on lower Poor Brook (P03 and P04) showed elevated bacteria (unrelated to sewage) on one occasion, but had also indicated a problem related to sewage during the first wet event.

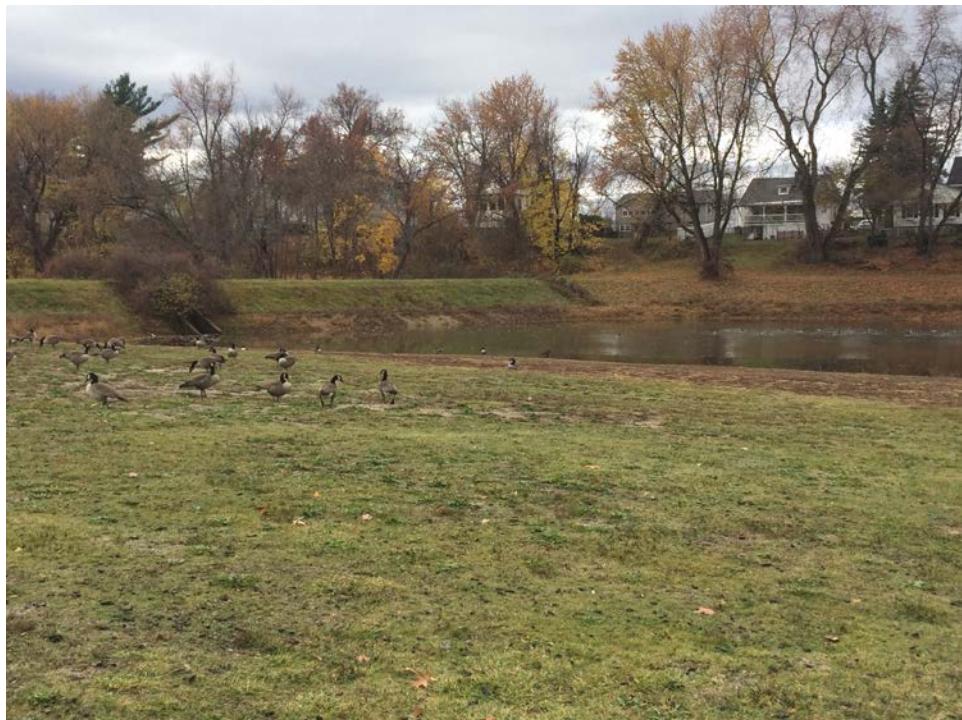
*Geese congregate along the shores of Bemis Pond in Szot Park, Chicopee.*

At Szot Park, engineering consultants for the project, Amec Foster Wheeler, in consultation with municipal officials, recommend addressing non-point source pollution primarily through source control (*i.e.*, discouraging of geese by transforming the landscape to be less attractive to waterfowl), and secondarily through structural BMPs (sediment forebay and bioretention swales). The serpentine nature of a bioswale allows potentially-impacted stormwater sheet flow from a large area to be captured, treated, filtered, and/or infiltrated prior to reaching the surface waters of the ponds. The sediment forebay will promote sediment removal prior to road runoff reaching the bioswale(s) and the ponds. Note that bioretention areas, sand filters, and tree boxes were not proposed at this location because drainage patterns do not flow to a central area, other than Upper and Lower Bemis Pond. Structural BMPs are not proposed within the ponds.

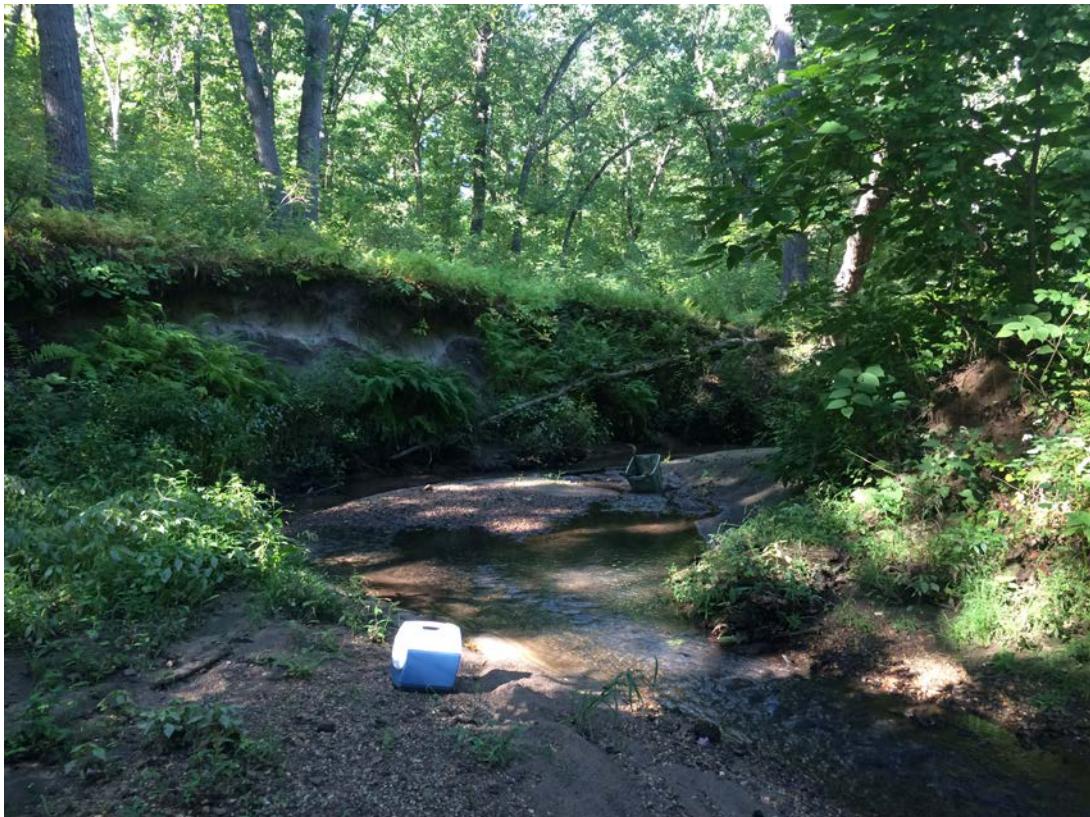
*While the Abbey Brook site at Mildred Avenue (A01E) did not show elevated *E. coli* levels, this upper part of the system is highly impacted from urbanized flows. Sampling at this site on 10/10/16, some 16 hours after a .37-inch storm, it is apparent that the real drama of what happens to this system occurs much closer to the storm event.*

The third round on 11/16/16 was preceded by 0.35" of rainfall, with rain beginning at 1 p.m. the previous day and ending around 7 p.m. Another site, just above A01B was added and the *E. coli* levels in this location were extremely high (as was A01B once again), suggesting that runoff carrying fecal matter from the geese could be a problem as the adjacent hillside drains to this area just above the pond, but also to Bemis Pond itself. Another contributing factor here could be beaver activity in the stretch of wetlands above Bemis Pond, where there is a large beaver dam that stretches from one bank of Abbey Brook to the other.
